Manhole Inspection Summary

Manhole # S37Y1_021MH

Insp Date: **11/29/07 9:12 AM**

Location Address: **3717 2nd St**

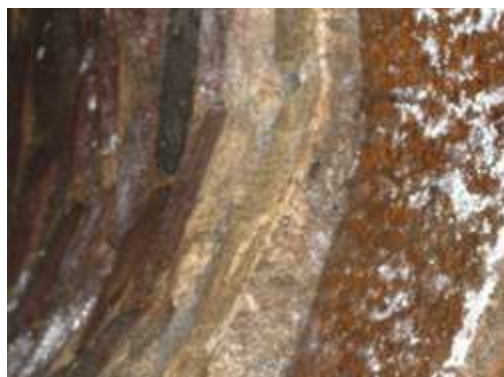
Defect 1

Condition: ☐ Sound ☐ Cracked ☐ Root Intrusion ☒ **Loose Brick** ☐ Deteriorated

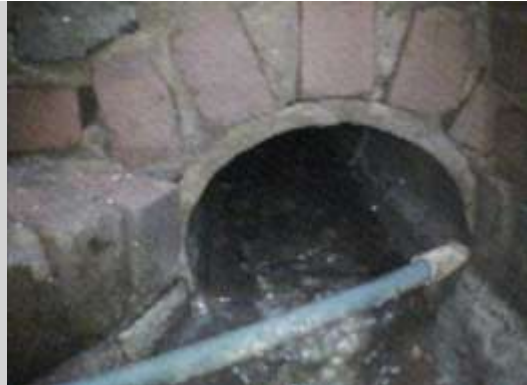
12 O'Clock Outflow

Pipe Height: **10.8** (in.) Rod and Bar (Angled)
Pipe Material: **Clay** ☐ Pipe Lined
Invert Depth: **11.66** (ft.) Flow Characteristics: **Fast**
Deposits: ☒ None ☐ Mud ☐ Sludge ☐ Debris ☐ Grease
Silt Depth: (in.) Deposits Extent:
Infiltration: **None** Pipe Seal Cond: **Sound**

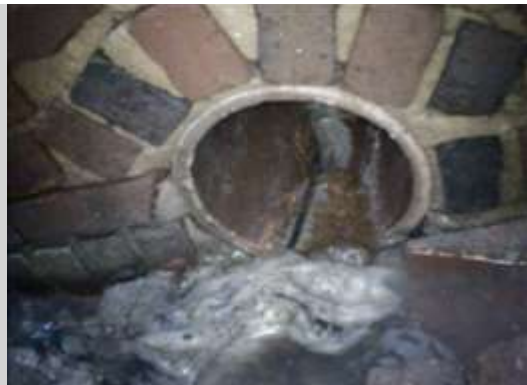
3 O'Clock Inflow

Pipe Height: **8.4** (in.) Rod and Bar (Angled)
Pipe Material: **Clay** ☐ Pipe Lined
Invert Depth: **10.81** (ft.) Flow Characteristics: **Fast**
Deposits: ☒ None ☐ Mud ☐ Sludge ☐ Debris ☐ Grease
Silt Depth: (in.) Deposits Extent:
Infiltration: **None** Pipe Seal Cond: **Sound**

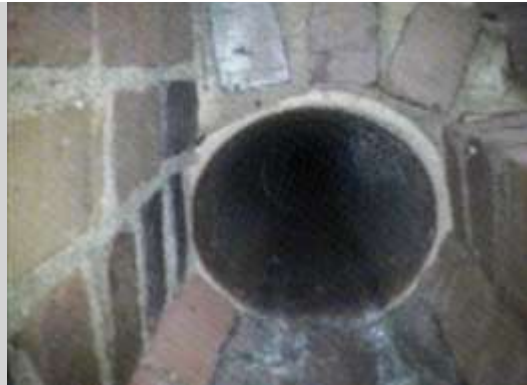
6 O'Clock Inflow

Pipe Height: **8.4** (in.) Rod and Bar (Angled)

Infiltration: **None** Pipe Seal Cond: **Sound**

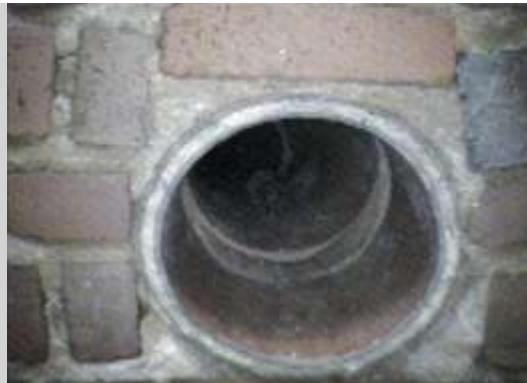
9 O'Clock Inflow

Invert Depth: **9.58** (ft.) Flow Characteristics: **None**

Infiltration: **None** Pipe Seal Cond: **Sound**

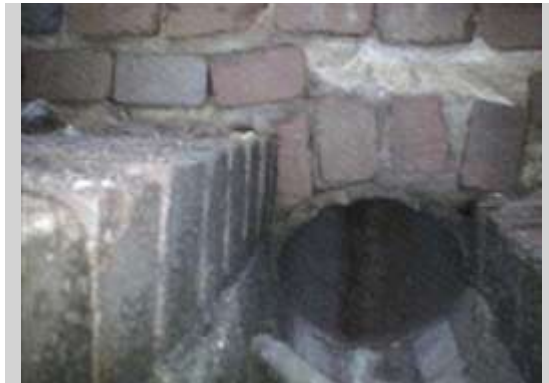
Drop In @ 9 O'Clock

Drop: **Outside** Rod and Bar

Drop Condition: **Open**
